The Poughkeepsie Railroad Bridge is set to reopen as a pedestrian walkway in October—thanks in part to two brave surveyors with high-tech GNSS equipment.

BY CHRISTINE L. GRAHL

PRECARIOUS POSITIONING

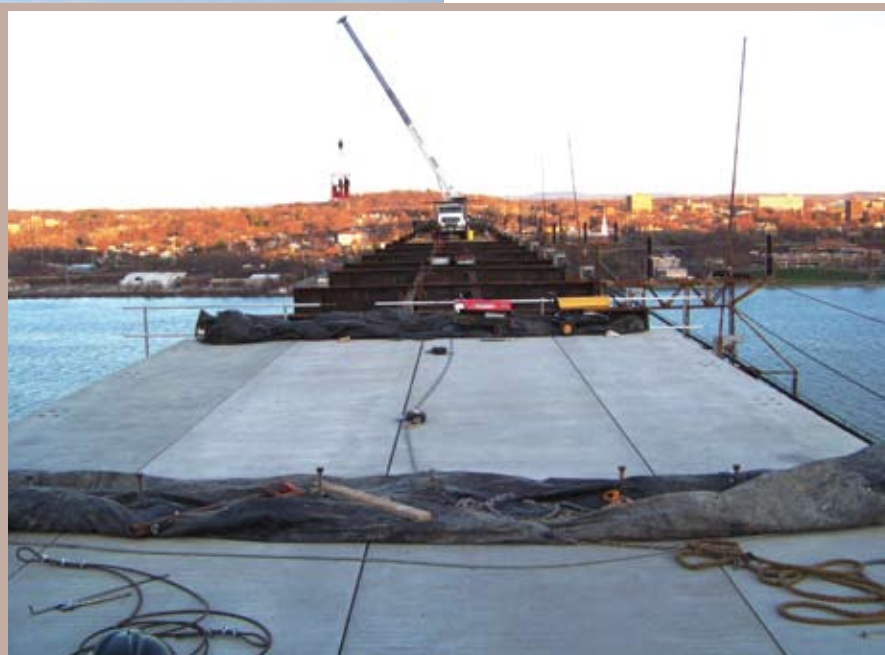
Left: Adolf Jonietz locates points on the curve of the east approach of the bridge. Above: Massive concrete panels are set in place for the new walkway.

Using GPS, the crew located points for the main span over the river, three in the center line of each U-beam and two along the easterly edge (one to the north of the center line and one to the south of the center line) as they edged out onto the bridge. They relocated the center-line U-beam and center-line bridge span on their return

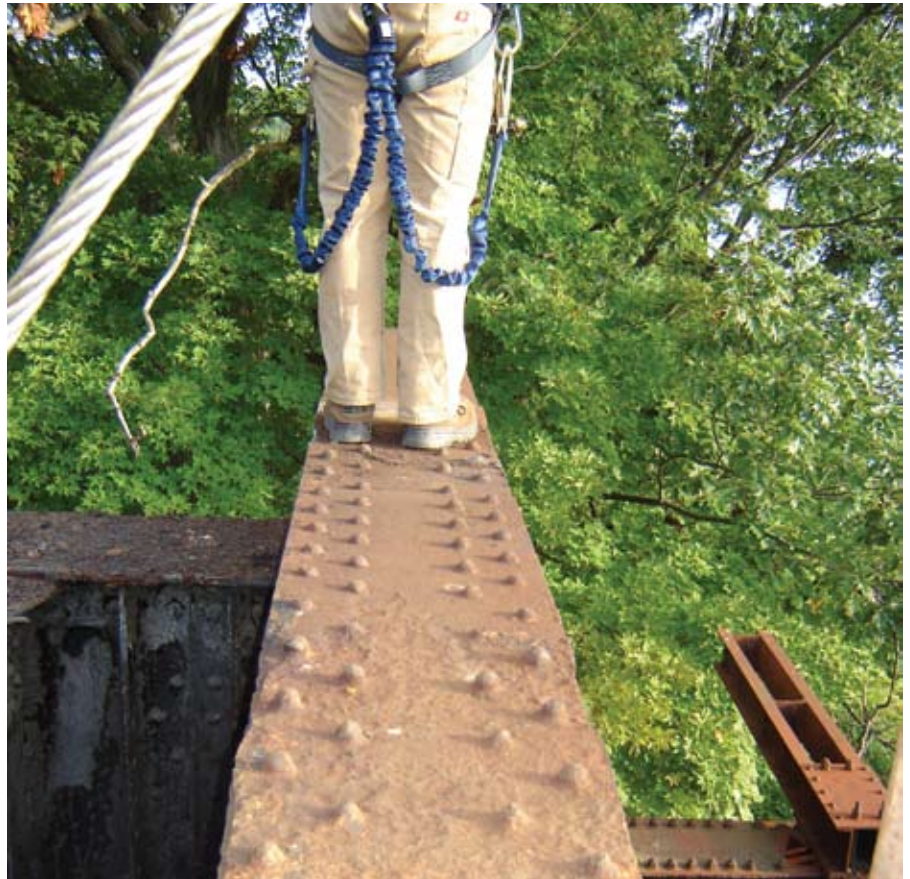
GPS equipment was used to gather the required data for the bridge work.

The steel beams on the bridge were only 15 inches wide at their widest point, which left no room to maneuver around a typical total station or any other instrument that required a tripod. Jonietz determined that GPS equipment would offer the best solution. He chose a Leica System 1200 SmartPole with GNSS control and a cell modem for real-time network (RTN) capability. "This equipment is lightweight and very versatile," Jonietz explains. "New York state has a free real-time network, so no base station was necessary. Additionally using the New York network tied us into the New York East state plane coordinate system. This provided us with immediate results that could be verified while we were still out on the bridge, eliminating return trips for corrections."
